ULDB Flight 517NT
Anomaly Review Status Report
presented to
NASA Balloon Working Group

30 June 2003

Chairman, Flight 517 NT Independent Review Board

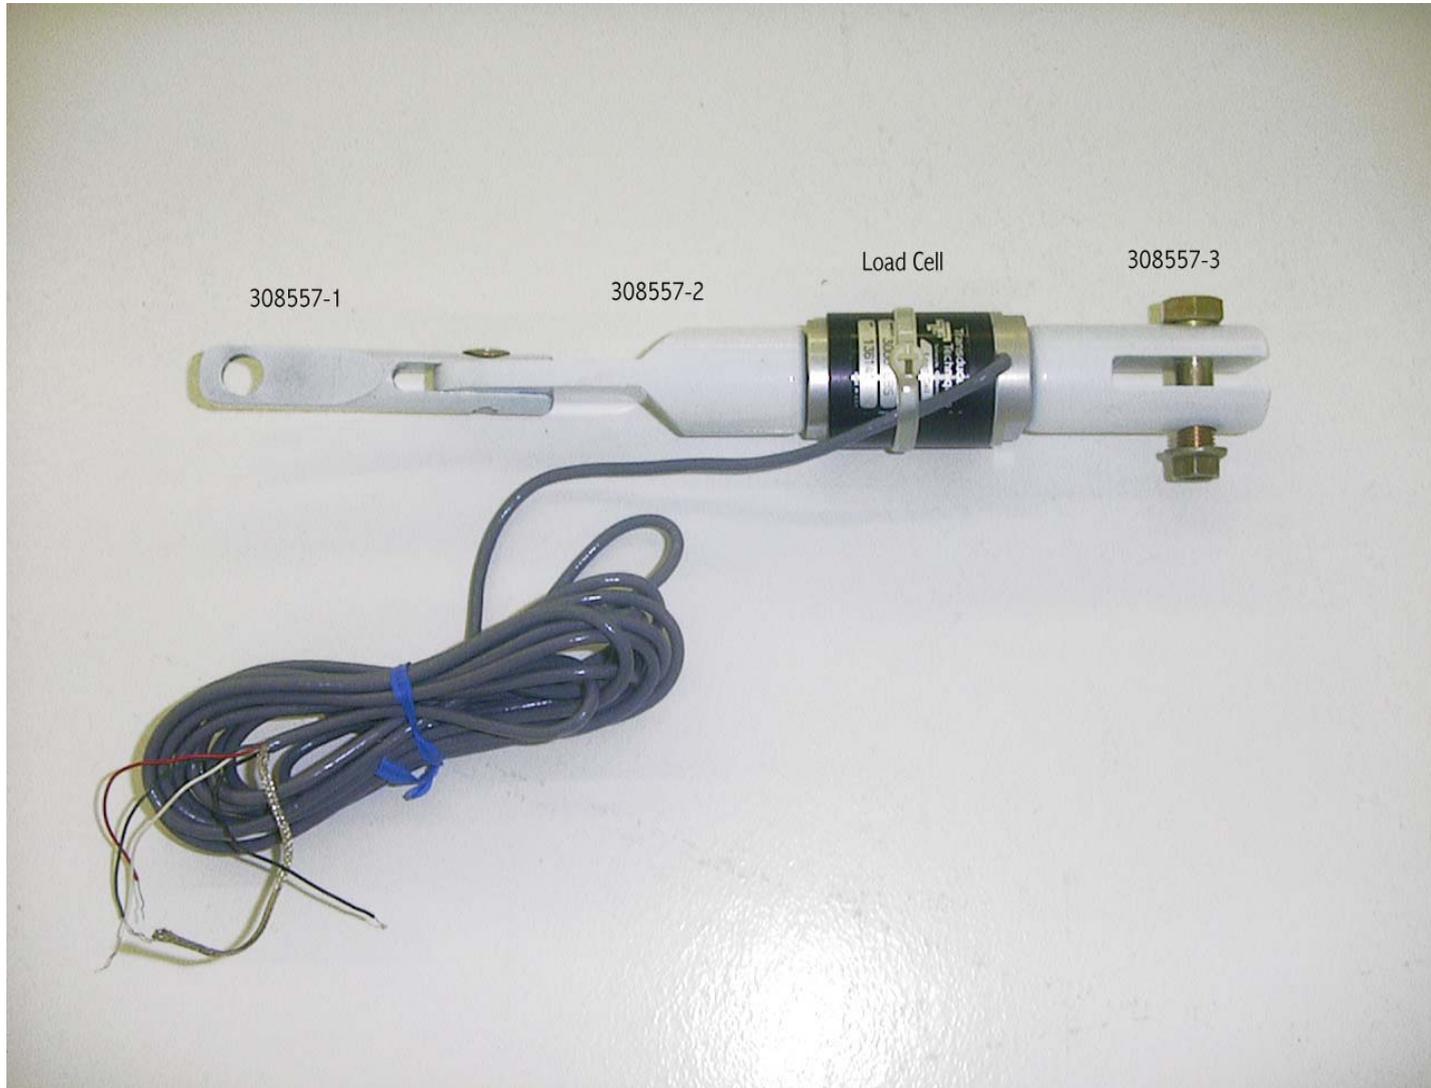
Load Cell Induced Damage

- **It was also observed that a load cell caused some damage to the film during launch and ascent**
 - **Load cell readings were zero before inflation, showed compression just as inflation started and changed to tension as the balloon began to pressurize**
